# PROBLEMS, CAUSES, AND CURES

Technical Publication No. C200 • Revised © 2018 | 3rd Edition

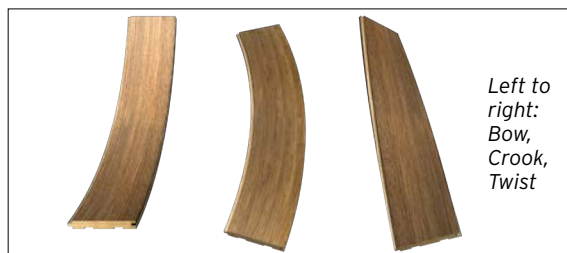
## Warp

**DEFINITION:** Any variation of the intended shape of a piece of wood flooring from a true or flat plane.

**Bow** - A deviation in the lengthwise flatness of a board, measured end to end.

- Solid wood flooring: Bow occurs when one side of the floor board shrinks more in length than the other. It causes the lengthwise curvature of the plank that resembles a bow used in archery. Because longitudinal shrinkage in solid wood is minimal, bow is normally not an issue that affects installation.
- Engineered wood flooring: Bow occurs when the wear layer and the core begin to shrink in opposing lengthwise directions, forcing the uninstalled planks to bow. Manufacturer and industry standards (HPVA) dictate tolerances and milling requirements for the amount of bow allowed in an engineered wood floor at the time of manufacture. This may or may not coincide with uninstalled flooring at the jobsite due to change in moisture content as a result of jobsite conditions.

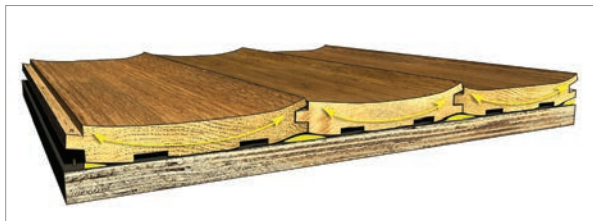
## Cupping

**DEFINITION:** A concave or dished appearance of individual boards with the edges of the board raised higher than the center. This is also a type of warp.

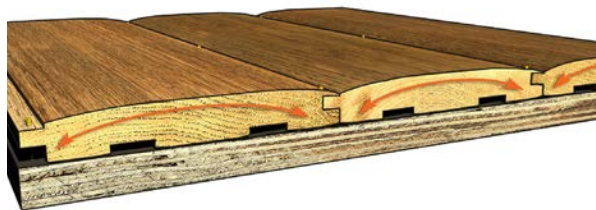
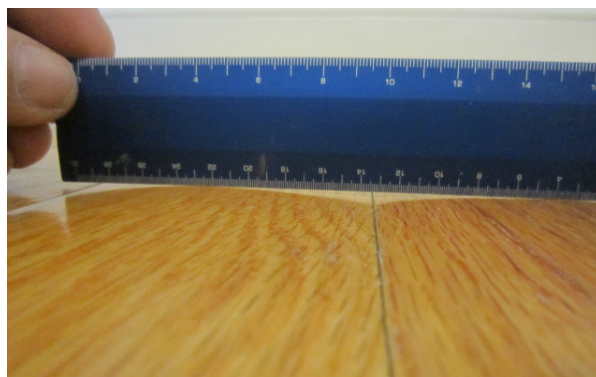
**Crowning**

**DEFINITION:** A convex or crowned appearance of individual boards with the center of the board higher than the edges. This can also be a type of warp.

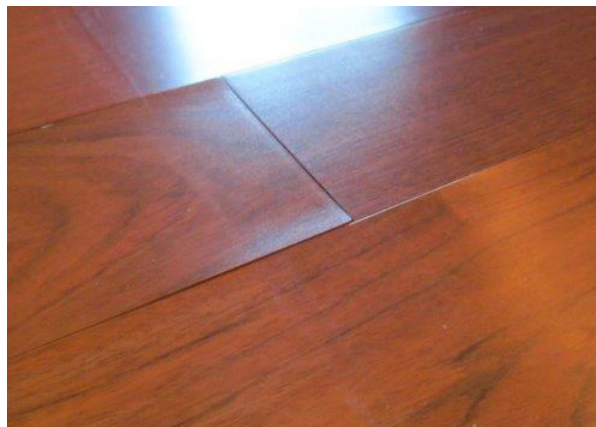
## Dry Cupping

**DEFINITION:** A concave or dished appearance of individual engineered flooring planks with the edges raised higher than the center.

- When relative humidity levels remain below the manufacturer's recommendations for long enough, engineered planks can begin to dry cup. When this happens, the wear layer loses moisture and begins to shrink across its outer face, which can exert enough force on the core material to pull the edges of the plank (often the groove side) upward. This causes a cupped appearance across the width of the board.

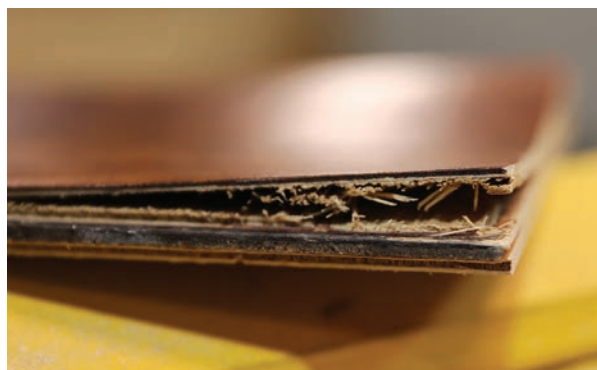
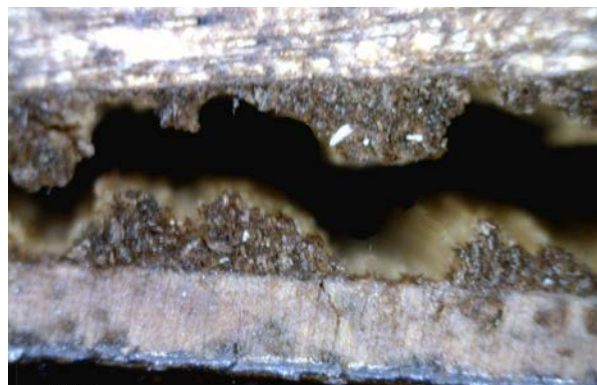
## Wood Shear (Engineered Flooring)

**DEFINITION:** External stresses exceeding the strength of the wood fibers within an individual plank of engineered flooring, resulting in the wood fibers being torn apart. When examining this type of failure in an engineered wood flooring plank, wood fibers will be visible at the point of separation, remaining bonded to the adhesive layer.

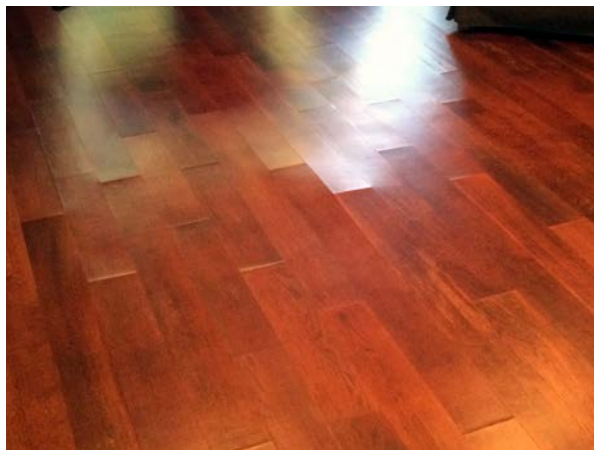
## Endlift/Ski (Engineered Flooring)

**DEFINITION:** A condition where the ends of installed engineered wood flooring boards deviate from the flat plane and appear raised or curved upward.

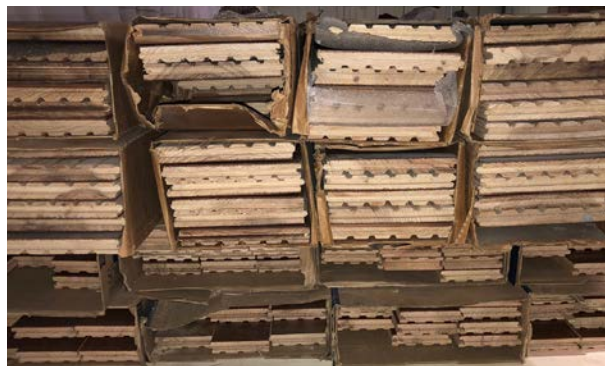
## End-Swell/Flared-Ends (Solid Flooring)

**DEFINITION:** A condition where the ends of solid wood flooring boards deviate from the flat plane and/or parallel plane, and may appear wider or thicker than the rest of the board.

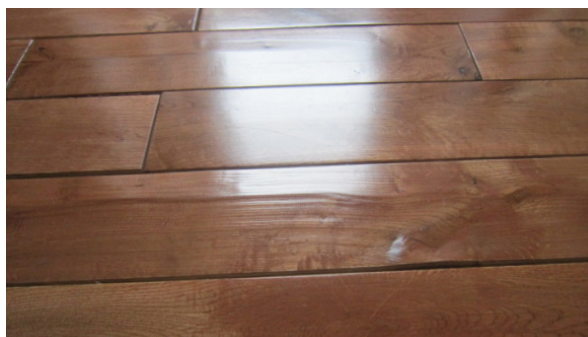
## Reaction or Juvenile Wood

**DEFINITION:** Natural and unique features, properties, and growth patterns in wood that cause it to appear and perform non-traditionally, resulting in distortions from non-uniform swelling and shrinking.

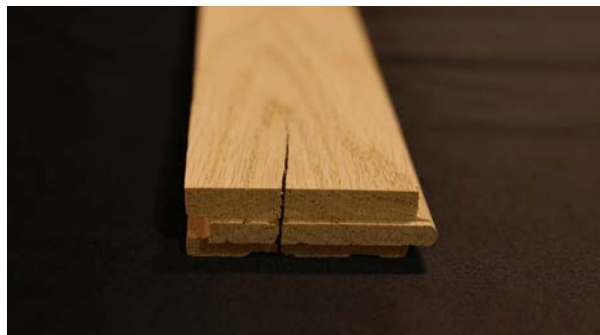
**End-Checks** - Like surface checks, end checks occur in, or adjacent to, the wood rays, but on the ends of the boards rather than the face. These separations occur due to the normal movement of moisture along the length of the boards, where the ends of the boards dry more rapidly leading to stress fractures on the ends of the boards.

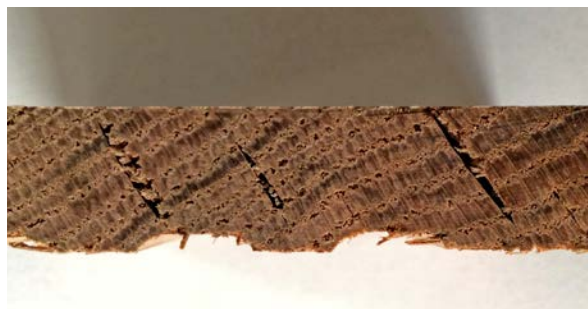
**Internal Checks (Honeycomb)** - An internal defect in the wood that may not be visible on the surface of the board, but occurs in the core (inner part of the board) of solid boards. These checks can become exposed when the boards are sanded or milled. They can also become exposed on the surface of the board with a loss in moisture or changes in RH after installation.

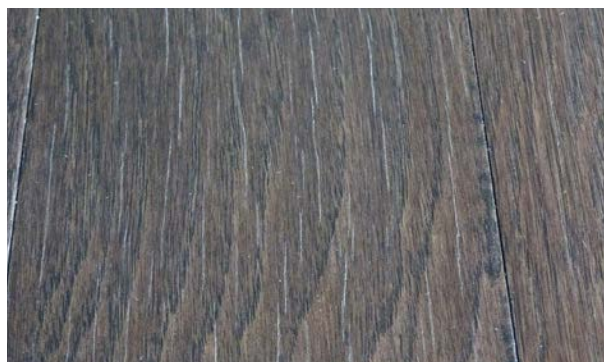
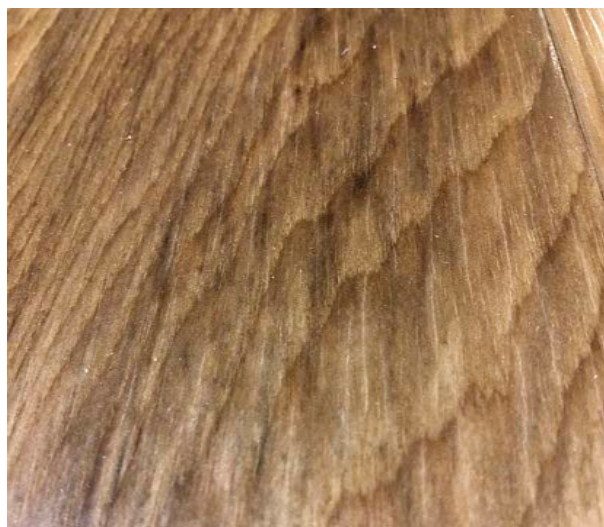
## Lathe Checks (Rotary Peeled/Sliced Engineered Flooring)

**DEFINITION:** In engineered flooring with rotary peeled or sliced face veneers, as the knife separates the veneer from the log, the separated sheet of wood is laid flat where stresses can occur in the region near the knife edge. If the strength of the wood is exceeded, this stress is relieved by separations (or checks) of the wood fibers parallel to the grain of the veneer at the knife edge. The knife edge of the veneer is known as the open (or loose) side, and the opposite side of the veneer is known as the closed (or tight) side. Lathe checks are not normally visible on the face of the finished board.

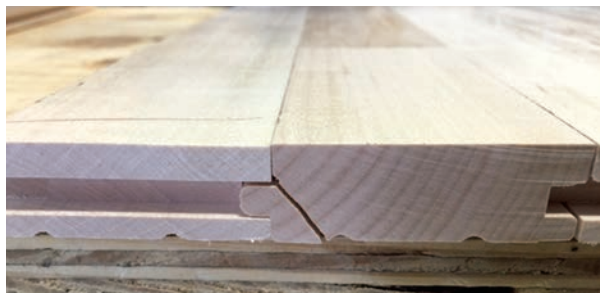
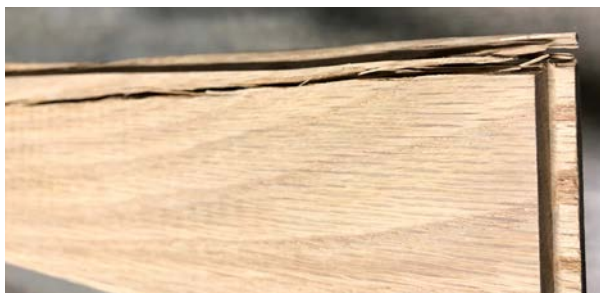
## Splits/Cracks

**DEFINITION:** A tearing apart or rupturing of the wood that may run at various angles to the growth rings.

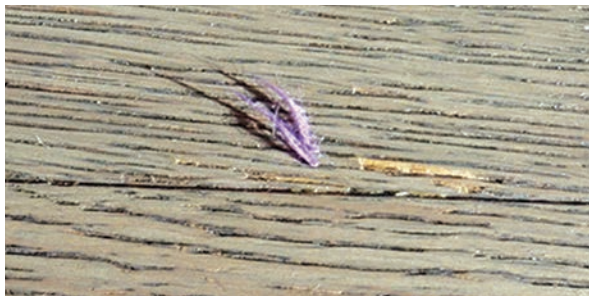
## Slivers/Splinters

**DEFINITION:** Sharp fragment of wood separated/fractured away from the edge or face of the board protruding from the floor.

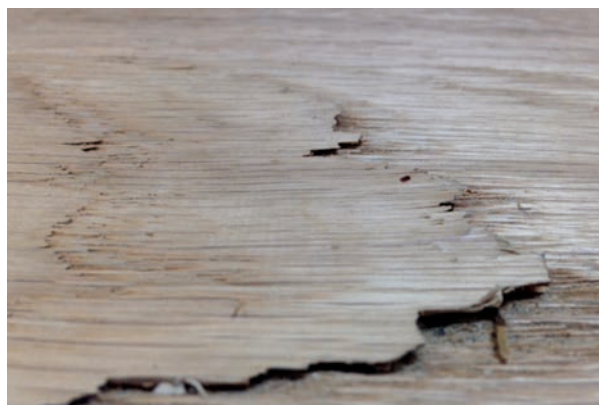
## Shake (Ring Shake/Ruptured Grain)

**DEFINITION:** A separation of the wood's fibers along the grain (parallel to the growth rings), that usually occurs between the rings of annual growth.

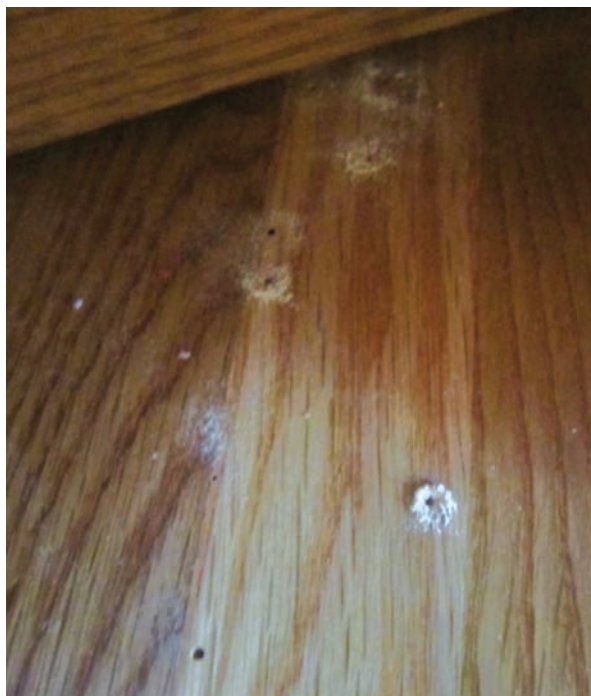
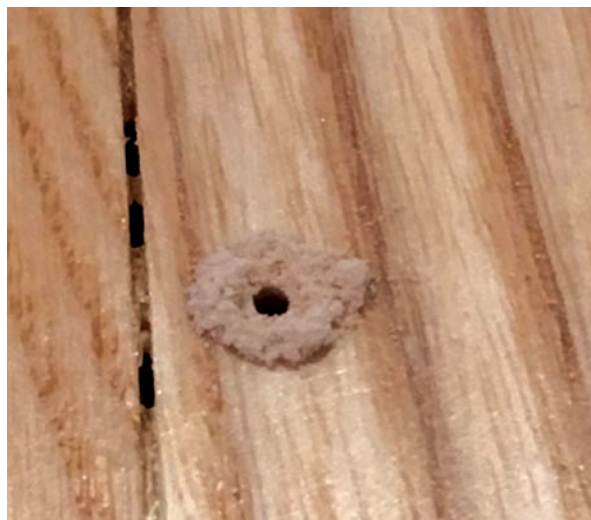
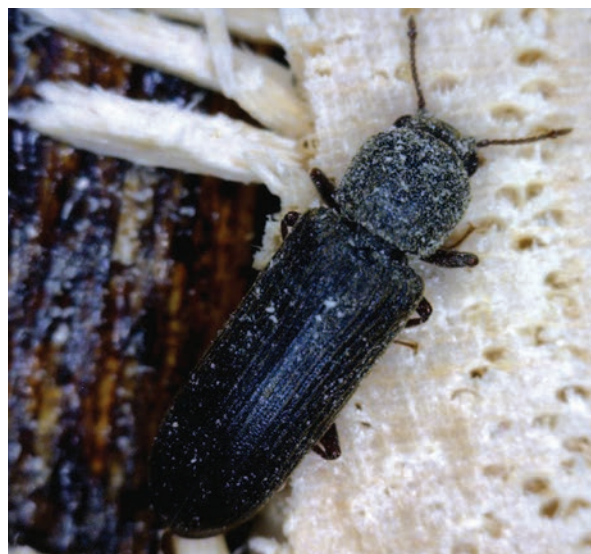
- **Powderpost (Lyctid/Anobiid) Beetle** - The larvae of wood-eating insects bore in and feed on the wood fibers causing damage to both hardwoods and softwoods. Properly kiln-dried lumber will normally eliminate powderpost beetles, but infestations can occur at any point after the kiln-drying process, including during storage, transport, or from other wood products.

- Infestation often occurs long before, but can even occur after the wood floor is installed. Female beetles lay their eggs within the pores of the bare, unfinished wood. The larvae feed on the wood, creating tunnels that fill with a powdery substance called frass. Later, when the larvae mature, they exit the wood, creating small pinholes, generally measuring 1mm-3mm (1/16"). In active infestations, the holes will be surrounded by this frass (light-colored powder). This frass material is very fine and will feel like talcum powder when rubbed between two fingers. The presence of an actual beetle, beetle larvae, or frass is the only way to absolutely confirm an active infestation.

- Improperly dried or stored lumber.
- Lyctid Powderpost Beetles are usually brought into the house in wood products that contains eggs or larvae that may have been in furniture, firewood, untreated reclaimed lumber, joists or framing, molding, trim, wood paneling, cabinets, or even the pallets used to transport the flooring.
- Termites and Anobiid Powderpost Beetles normally prefer to infest wood that is damp; therefore, infestations usually begin in moist, poorly ventilated areas such as in unconditioned crawl spaces or basements.

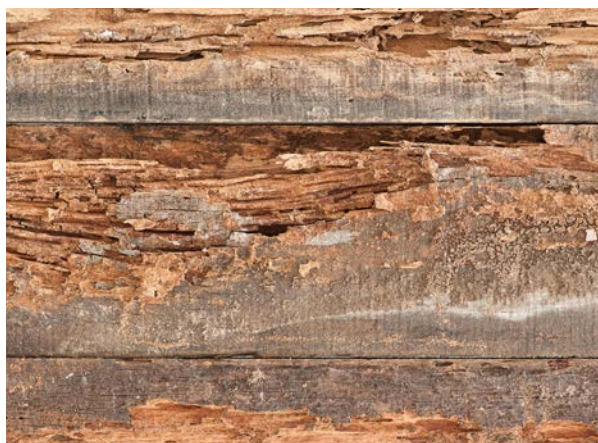
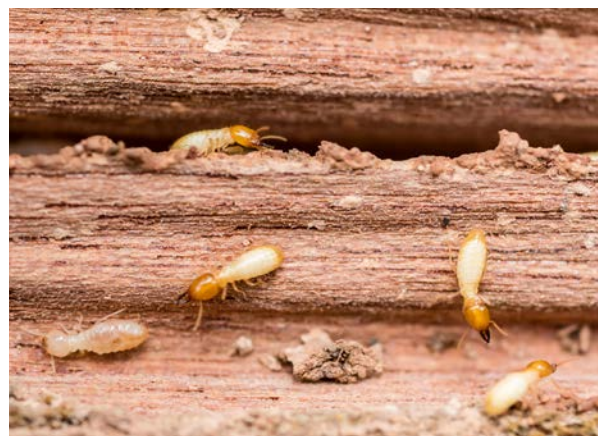
- **Termites** - Termites are attracted to areas where moisture accumulates in and around your home, including damp basements, laundry rooms, bathrooms, and leaky foundation walls.
  - Termites will eat any kind of wood including mulch, rotting wood, new wood, painted wood, and treated wood.
  - Stagnant, moist air in the home provides the perfect breeding ground for termites.
  - Termite-damaged wood is usually hollowed out along the grain, with bits of dried mud or soil lining the feeding galleries. Wood damaged by moisture or other types of insects will not have this appearance.
  - Termite infestations are a site-specific condition.

- Reduce and maintain moisture levels below 12% in and below the floor.
- **Termites:**
  - Termite treatment should be conducted by a professional. The company should be licensed by the Department of Agriculture or agency responsible for regulating termite control in your state. The treatment professional may use one of two general categories of termite treatment, liquids or baits.

- Since termites require wood with high moisture content, correction of the moisture source is necessary.
  - Structural damage should be repaired. Damaged flooring should be removed and replaced.

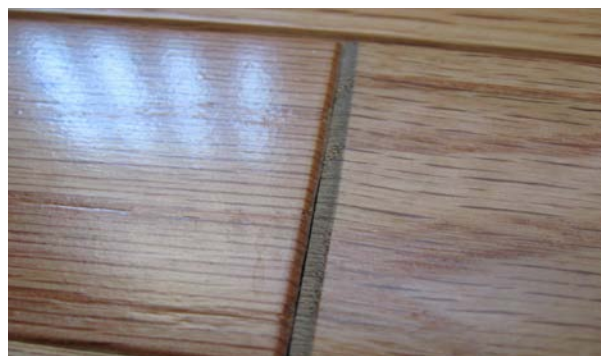
## Uneven Bevels

**DEFINITION:** Bevels within an installed or uninstalled wood floor appear inconsistent in width, depth, shape, profile, or size.

- Mis-milled flooring.
- Flooring installed from different product lines/manufacturers/runs.
- Normal and within grade for flooring installed (such as hand scraped/distressed/reclaimed).
- An existing floor with bevels that was resanded and resulted in uneven bevels.
- Installer manipulated material.

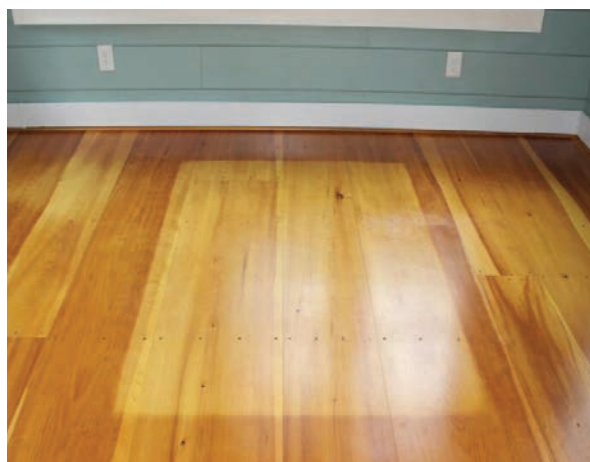
## Wood Discoloration

**DEFINITION:** The wood itself changes color over time (darkens or lightens).

- Wood changes color through oxidation and/or photochemical exposure, which is a change that cannot be prevented. This is a naturally occurring phenomenon. All woods will change color, but some more drastically than others. This is a natural change, and should be taken into account when selecting flooring from sample boards.

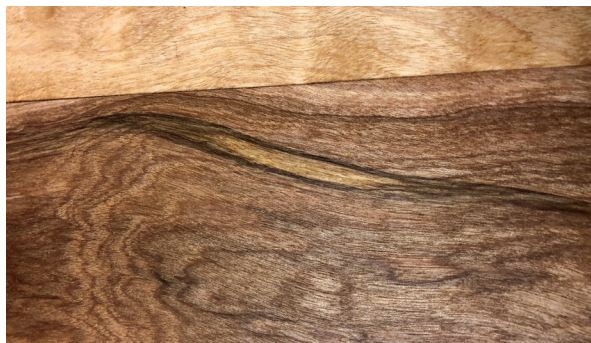
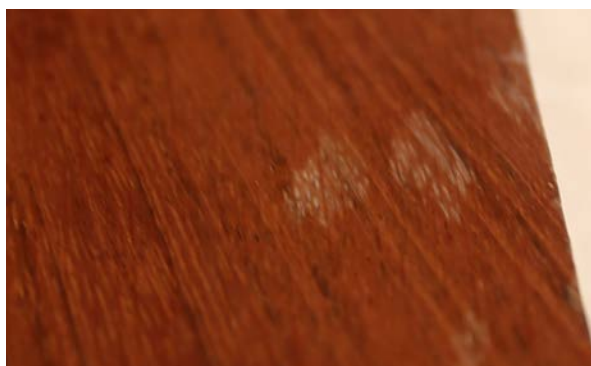
## Mineral Streaks/Deposits

**DEFINITION:** A discolored line, spot, or band in the wood that may range in color from light gray to tan, olive green, brown, purple, blue, or black. Mineral streaks/deposits are naturally occurring and they are often considered to add value and appeal to the wood.

- The source of these mineral streaks/deposits is often undetermined, and is considered a naturally occurring characteristic of living trees. These deposits may develop as the tree absorbs and deposits minerals from the surrounding soil such as limestone, sulfur, nitrogen, phosphorus, potassium, silica, gypsum, or any other mineral found in the region where the tree was grown.
- Some mineral deposits such as silica are often mistaken for chemical stains in some imported species, because of how they may appear as spots or blotches.
- Some mineral streaks may be caused by normal cell physiology occurring from wounds caused by insects, animals, weather, or logging.

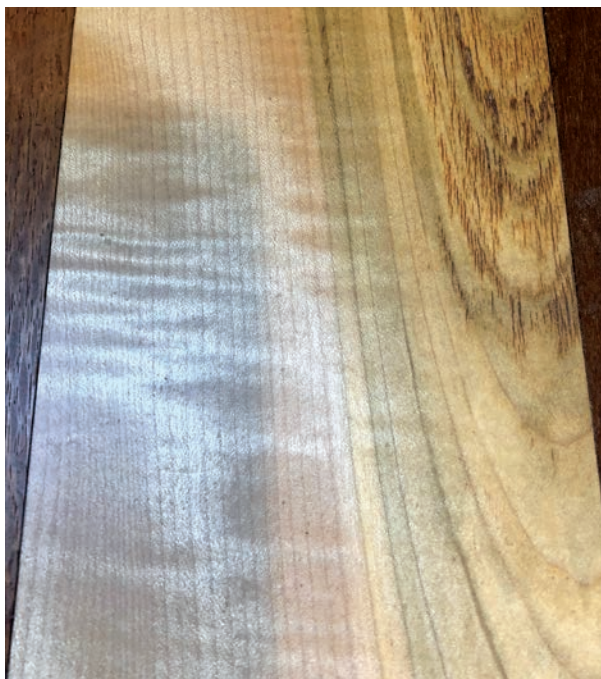
## Sap Stains (Blue-Stain or Brown-Stain)

**DEFINITION:** A discoloration in the sapwood. Sapwood itself is the active wood near the outside of the living tree. It is often lighter in color than the heartwood of the tree. Sapwood color variation is normal and acceptable in all grades, and must not be confused with sap stain.

- Sap stain is caused by the growth of certain fungi on the surface and in the interior of the wood when the moisture content and surrounding conditions are prime for this fungal growth. The wood may become prone to this fungi in standing or fallen timber, or during seasoning prior to the kiln-drying process.
- This discoloration is often known as Blue-Stain or Brown-Stain due to the color of the fungi. In kiln-dried lumber, this fungus is not living, does not cause decay, is not a mold, will not spread, is not a health concern, and will not affect the structural integrity or the strength of the wood.

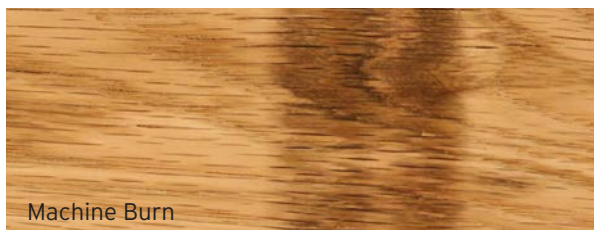
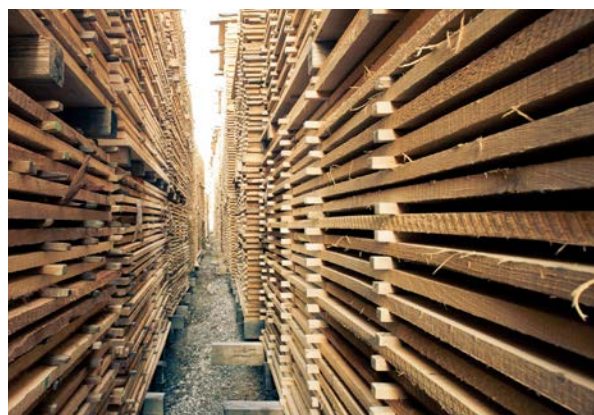
## Sticker Stains/Shadow

**DEFINITION:** A discoloration on the face of a board associated with the location of the stacker sticker. Sticker stain should not be confused with machine burn, which may look similar, but will often sand out.

- Stickers are thin strips or boards used to separate the layers of lumber stacked in a pile in order to permit air circulation during seasoning. These stickers can leave a brown or blue stain that develops in seasoning lumber where it has been in direct contact with the boards.
- Sticker stain discoloration is the result of naturally occurring chemicals within the wood (drying wood and/or stickers) that occur during the drying process.
- Seldom, if ever, will there be any fungi associated with sticker stains.

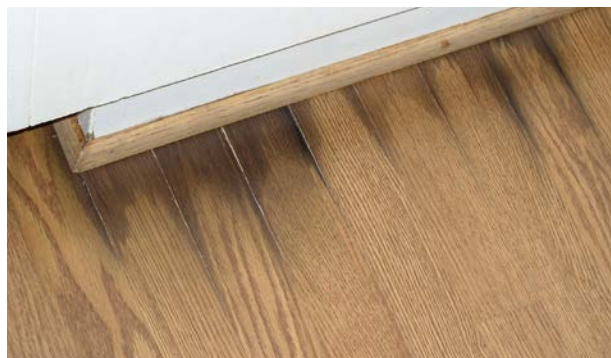
## Moisture Stains

**DEFINITION:** The wood or finish changes color with exposure to moisture.

- Moisture from below can cause dark staining, or a white haze between seams and on the surface of the wood.
- Topical moisture (incompatible maintenance products, spills, steam, etc.) can cause blushing or damage to the finish itself.

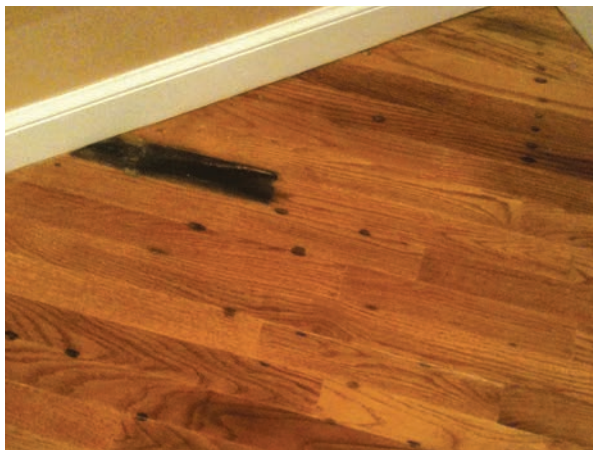
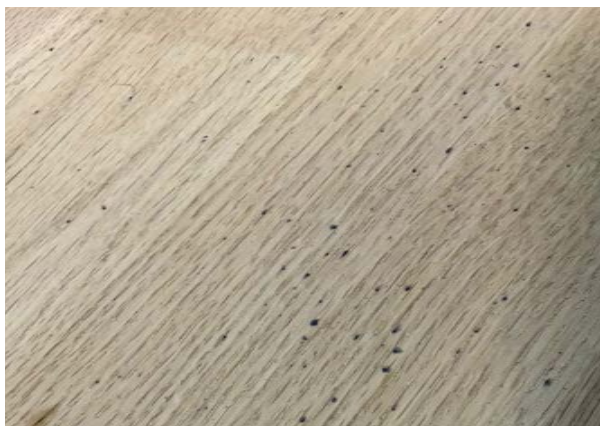
## Iron Stains

**DEFINITION:** A result of a chemical reaction between wood tannins, water, and iron.

- A chemical reaction between extractives in the wood and iron in steel products, such as nails, screws, and other fasteners and appendages.
- Floor scraper filings/shavings left on the flooring surface that reacts with water or water-based products.
- Residual from some types of abrasives left on the flooring surface that reacts with water-based products.
- In extreme moisture condition cases, substrate exposure to moisture leaching into the wood floor from below (iron fasteners or from within the slab).
- Metal containers or objects (such as paint or watering cans) in direct contact with the floor, which have been exposed to moisture.

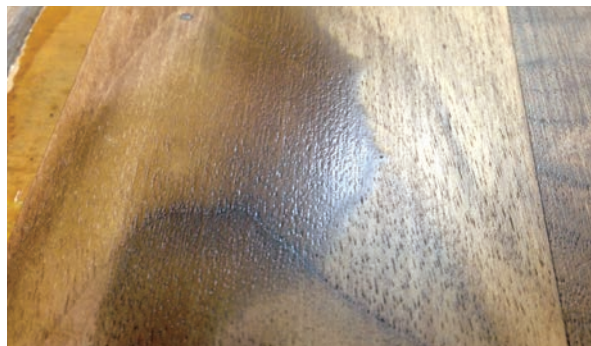
## Tannic Acid Discoloration/ Tannin-Pull

**DEFINITION:** Tannic acid includes various naturally occurring soluble astringent complex phenolic substances found in trees (and plants) as a way of protecting the tree from insects, fire, and bacteria. High levels of tannic acid present in woods like oak, walnut, and mahogany can produce a dark discoloration when coming in contact with some products used in the finishing and maintenance of wood floors.

- Tannic acid is water-soluble and may discolor when it comes in contact with iron and water, which usually appears as a bluish/grey discoloration on the wood.
- Tannic acid discolors when it comes in contact with materials that are alkaline by nature, such as ammonia. Most water-based finishes are manufactured with pH adjusters (such as ammonia), which can cause a green/brown discoloration on the surface of the wood, and may also partially bleed into the finish.
- Unevenly applied water-based coatings, especially heavy spots, puddles or streaks.
- Not using or improper application of a tannin-blocking sealer.
- Application of a top-coat over a sealer that has not adequately dried.

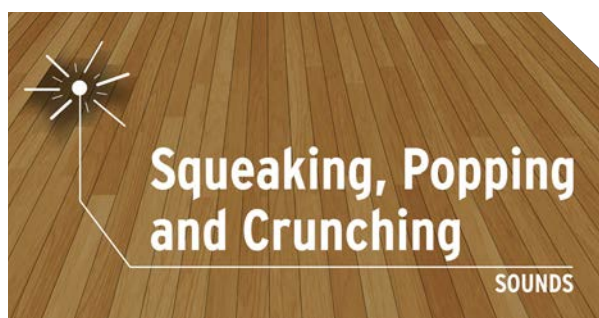
## Squeaking/Popping/ Crunching Sounds

**DEFINITION:** Audible squeaking, popping, or crunching noises in an installed wood floor or within the floor system. Squeaks are not a direct concern with the installed wood floor as long as movement accompanying the audible squeak does not affect the performance of the installation. An occasional squeak within any properly installed wood floor system is not abnormal.

- Old age of the floor and/or structure.
- Wood flooring installed while not in equilibrium with the end-use environment. A change in temperature/humidity that causes the wood floor to change moisture content, and ultimately change dimension of the flooring and tongue and groove match, can result in audible noises, squeaks, pops, or crunching sounds.

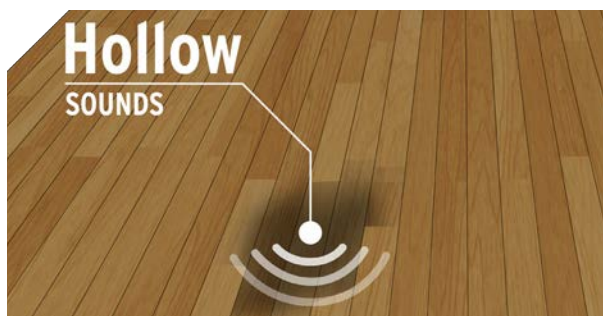
## Hollow Sounds

**DEFINITION:** An audible hollow sound in the installed wood flooring. When no deflection is present, this may be considered normal with many installation methods provided that the installation followed proper installation procedures. Hollow sounds are not a direct concern with the performance of an installed wood floor as long as there is not movement accompanying the audible hollow sound.

- Nail-down wood floors:
  - A void in the flooring itself (wormholes, shake, bark pockets, engineered flooring core voids, etc.).
  - Slight imperfections or voids in the subfloor.

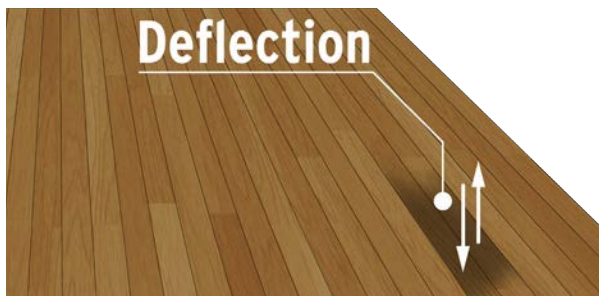
## Deflection

**DEFINITION:** Isolated areas in an installed floor system that exhibit vertical (up and down) movement when pressure is applied.

- A void in the flooring itself (wormholes, shake, bark pockets, engineered flooring core voids, etc.) resulting in vertical movement.
- Mis-milled flooring/loose tongue and groove engagement (outside of manufacturing tolerances at the time material was manufactured).

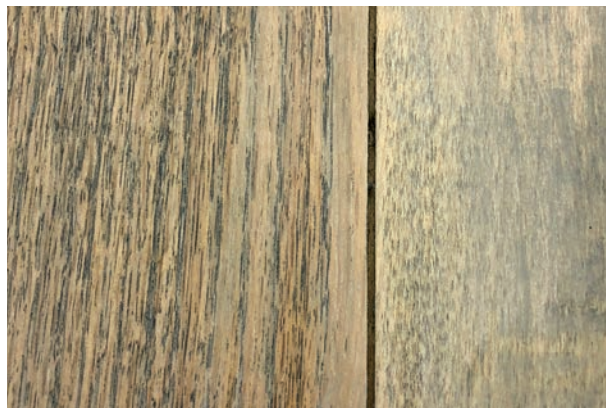
## Seasonal/Normal Gaps

**DEFINITION:** Gaps that appear between individual boards, opening and closing with seasonal humidity changes. Wider boards can experience wider gaps. Gap size is directly related and proportional to the board width.

- Most normal gaps are caused by seasonal fluctuations in relative humidity. The floor expands with high humidity and contracts with periods of low humidity. This type of expansion and contraction is considered to be normal and expected with wood floors when exposed to seasonal variations.
- When wood flooring is installed during dry seasons where relative humidity is not maintained, it is normal to leave internal expansion spaces/gaps (washer rows) within the floor to accommodate for seasonal humidity changes.

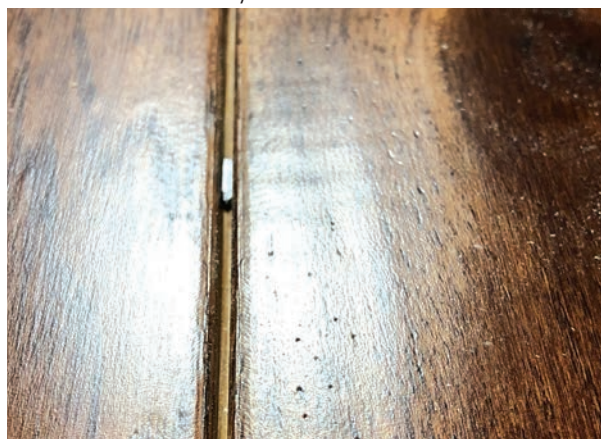
## Abnormal Gaps

**DEFINITION:** Gaps between abutting wood floor boards in the installed floor that were not intentionally placed and remain with seasonal fluctuations in moisture and humidity.

- Flooring not installed tightly together.
- Debris between the boards during installation.
- Solid wood flooring installed at higher moisture content than what the normal, in-service conditions can support.

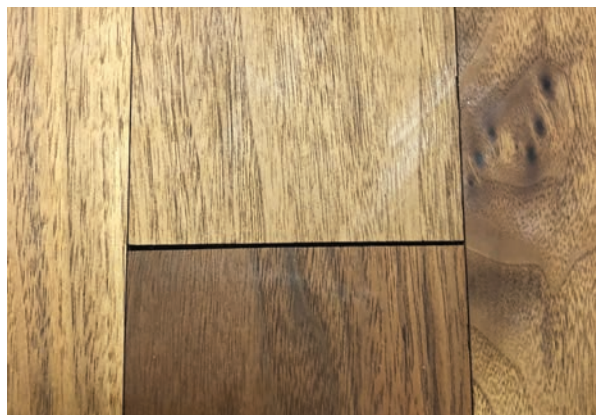
## End-Gaps

**DEFINITION:** A separation that occurs on the ends of two abutting wood floor boards.

- Loss/gain of moisture in engineered flooring.
  - Due to the construction of engineered flooring, each layer shrinks and swells in different directions and at different rates than the adjoining layers. It is common for it to shrink/swell in its length when exposed to changes in moisture content.

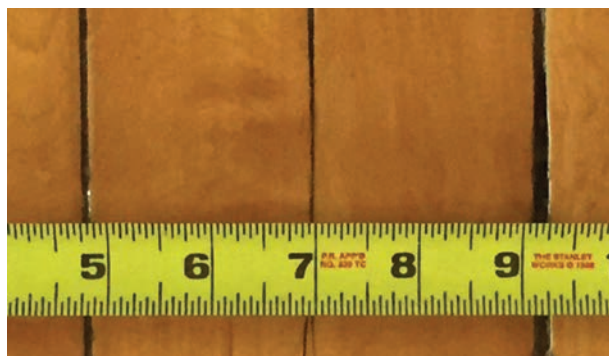
## Compression-Set

**DEFINITION:** A generally uniform appearance of gaps between wood floor boards that directly coincides with the narrowing/crushing of individual board edges as a result of permanent cellular damage. The appearance of a compression-set floor may be similar to gaps from other causes, such as flooring that was milled and installed with high moisture content. When they are at the same moisture content at which they were milled, compression-set boards will be narrower than the milled width and may exhibit slightly raised edges along the board edges.

- Exposure to substantial moisture causing excessive expansion, and resulting in damage to board edges, followed by lower moisture levels and subsequent contraction of the affected boards.
- Once the wood fibers have been damaged, they may be unable to regain their original dimensions.
- The compression can become exaggerated by debris becoming embedded in the gaps between boards.
- Filling seasonal gaps during the dry season can cause compression-set when the floor expands again during the more-humid months.

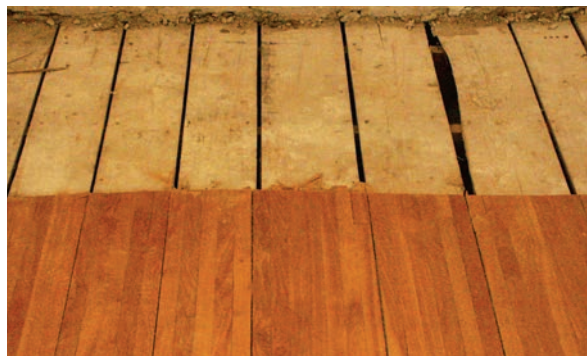
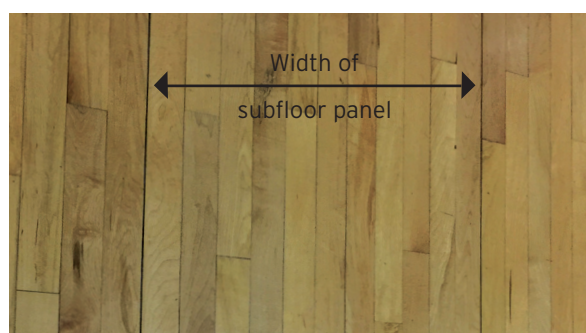
## Panelization

**DEFINITION:** A generally uniform appearance of gaps or peaks in the surfaces of the wood floor that directly coincide with movement in the subfloor material beneath it.

- Moisture-related subfloor issues.
- Acclimation related issues:
  - Moisture content of the wood floor and subfloor are not aligned at the time of installation.

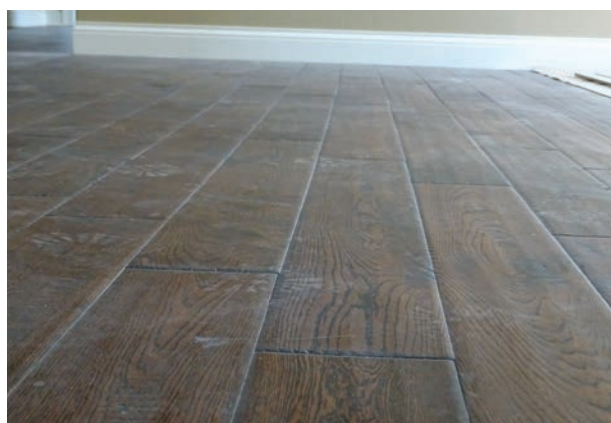
## Crooked Installation Discrepancies

**DEFINITION:** An installed wood floor appearing bowed or out-of-square within the room in which it is installed. No wood floor installation is perfectly straight, parallel, or perpendicular to walls or fixtures. When the straightness of the installed floor takes away from the overall appearance of the floor within the structure, an aesthetic remedy may be necessary. The performance and structural integrity of the wood floor is not normally affected with any floor that has been installed out-of-square or out-of-a-straight-line.

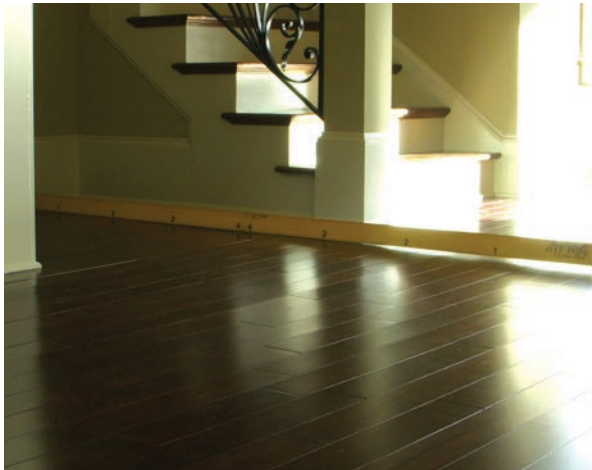
**DEFINITION:** The installed wood floor system appears to be uneven, wavy, or out of flat. Wood floors may be installed over out-of-level subfloors, but should fall within NWFA floor flatness tolerances. Subfloor flatness cannot be quantifiably measured when a floor covering is in place over it (without potentially extensive destructive testing), however, may give a good indication of what is happening below.

It is the responsibility of the flooring installer to assess substrate flatness, moisture requirements, and panel thickness/joist span combinations prior to installation. Reference NWFA Wood Flooring Installation Guidelines, and the flooring manufacturer installation instructions, for applicable tolerances. Gradual variations in subfloor flatness may not affect the performance of the installed wood floor, but may be considered unacceptable when overwood, vertical movement, slight gapping, squeaking, or noisy floors are present.

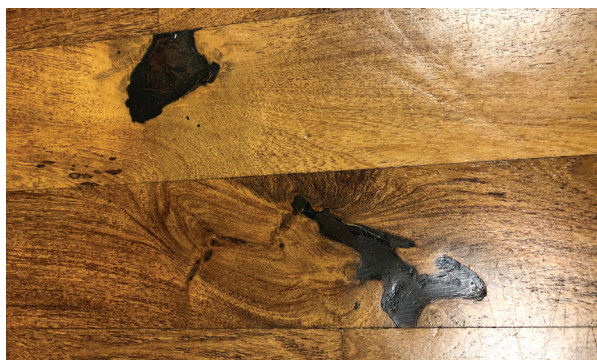
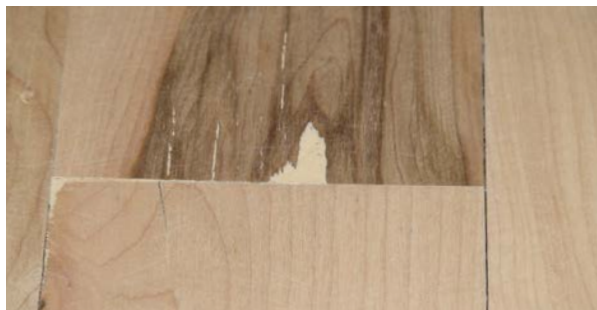
## Filler Color Variation

**DEFINITION:** The wood filler from one area of the floor is different from the overall color tone of the floor. No two trees from the same species are identical, no two boards from the same tree are identical, and color and grain patterns can vary even within one individual plank of wood. Wood filler will never perfectly match, nor is it designed to match every board within a wood floor.

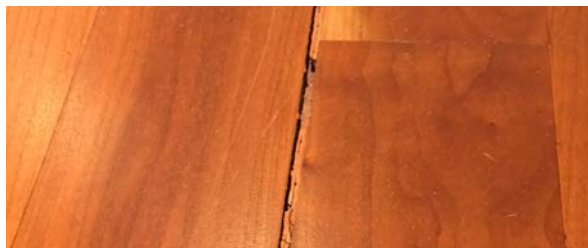
## Popped Filler

**DEFINITION:** Wood floor filler that has become loose or no longer fills the void it was once in.

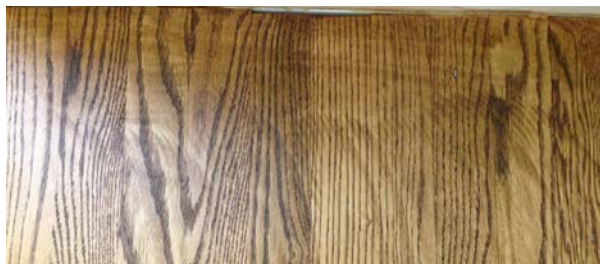
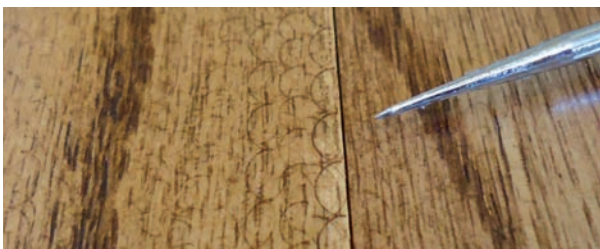
## Sanding Marks

**DEFINITION:** Sanding imperfections seen as drum marks, side cuts, sanding scratches, or swirl marks. Sanding marks should be viewed from a standing position on the floor being assessed, in ambient lighting conditions. Glare from a direct light source must not be used during evaluation. Inspection may take place from floor level and/or with assistance of magnification in order to determine causes of irregularities, but not to determine acceptability.

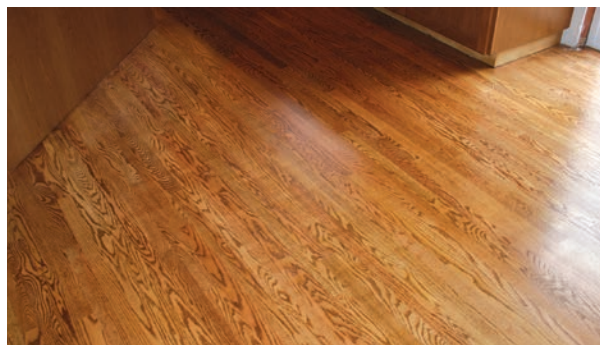
## Chatter

**DEFINITION:** Slight unintentional indentations causing a ripple-like wave effects or “bars” that run perpendicular to the wood’s grain direction on the surface of a wood floor which can become visibly pronounced in direct lighting. The width of these “bars” can range from just a few millimeters to nearly an inch from peak to peak, and can occur in limited regions or can span the entire floor.

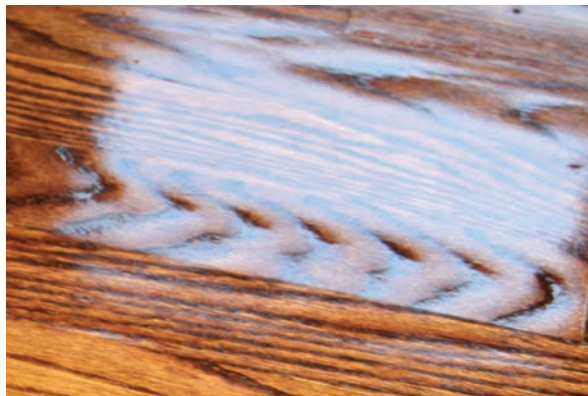
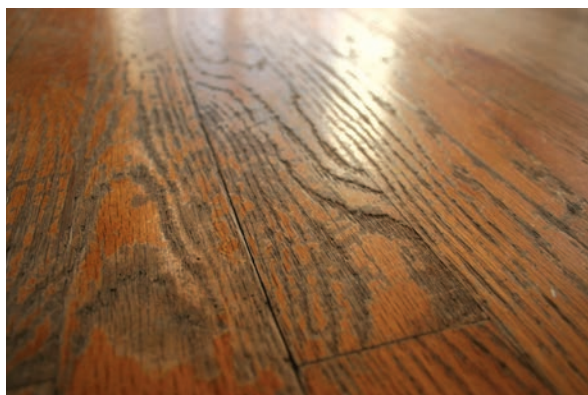
## Dishout/Shellout

**DEFINITION:** Undulations in the surface of individual boards or within the wood floor, resulting from softer areas having been worn, hollowed, or sanded to a lower level than harder adjacent areas.

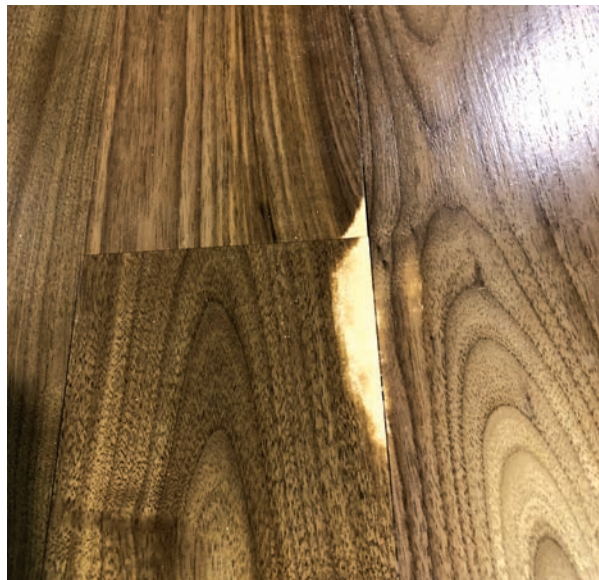
## Veneer Sand-Through

**DEFINITION:** The top/wear layer veneer (lamina) of engineered flooring has been completely sanded through to the core layer.

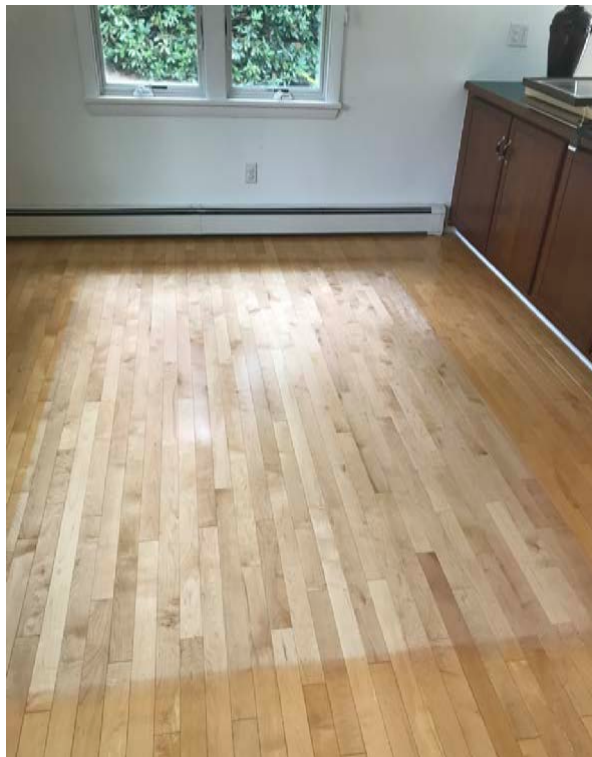
## Finish/Colorant Discoloration

**DEFINITION:** The finish or colorant systems changes color.

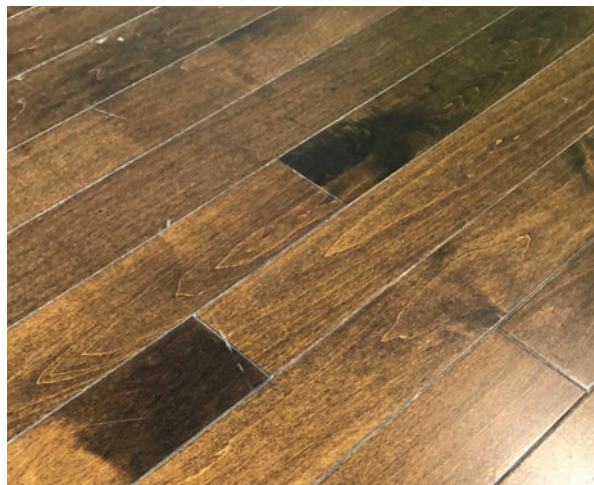
## Blotchy Stain/Colorant

**DEFINITION:** The appearance of an inconsistent stain or colorant from one area of a finished floor to another. Stained/colored floors should be uniform in color. Color tones may vary from board to board or within individual boards due to natural variances within the wood.

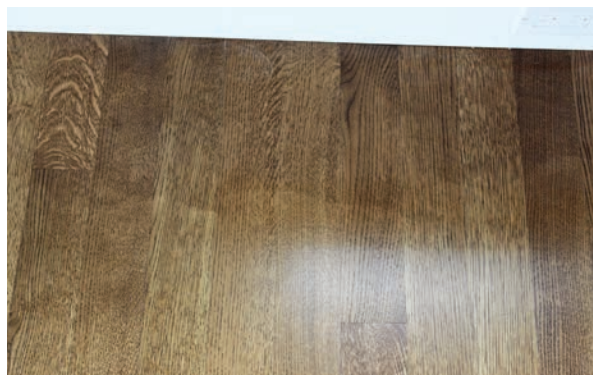
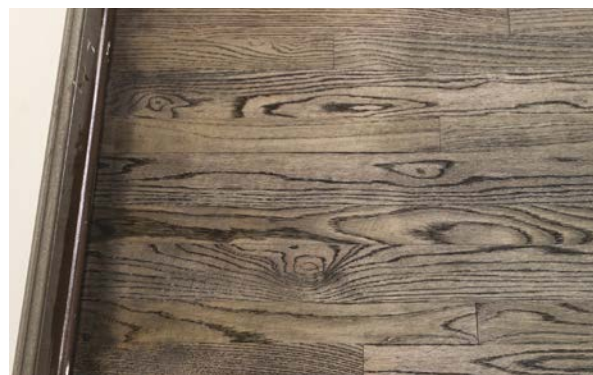
## Picture Framing/Halo

**DEFINITION:** The edges of the room appear to be a slightly different color than the rest of the room.

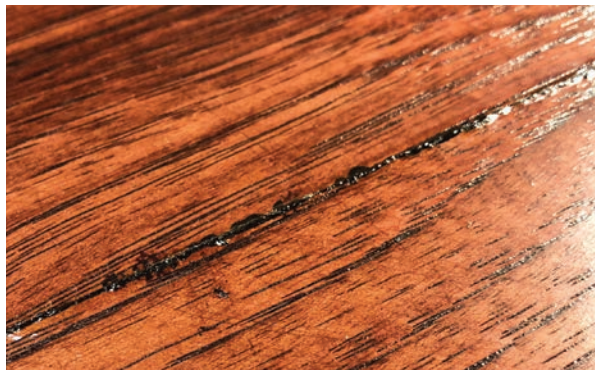
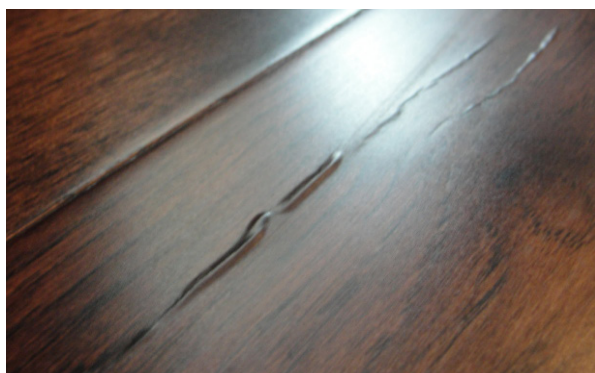
## Stain Bleed Back

**DEFINITION:** A staining phenomenon occurring after the initial application of the stain, where the stain seeps back to the surface of the wood. This may happen at board seams, with open-grain species, tight grain, knots, or burls.

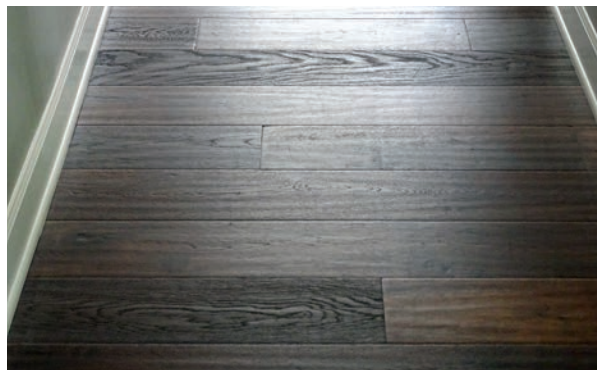
## Finish Film-Thickness Discrepancy

**DEFINITION:** A discrepancy in the depth of the film of finish applied to a wood floor. Mil/film thickness of finish can be evaluated, but should not determine acceptability.

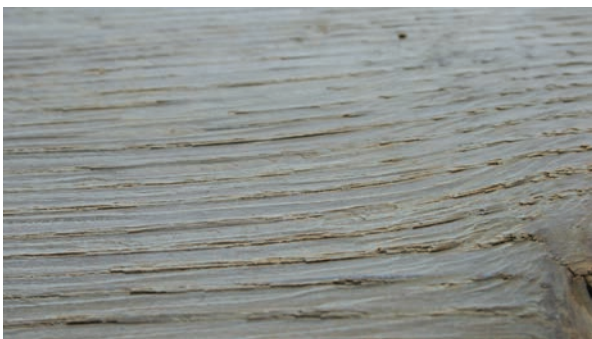
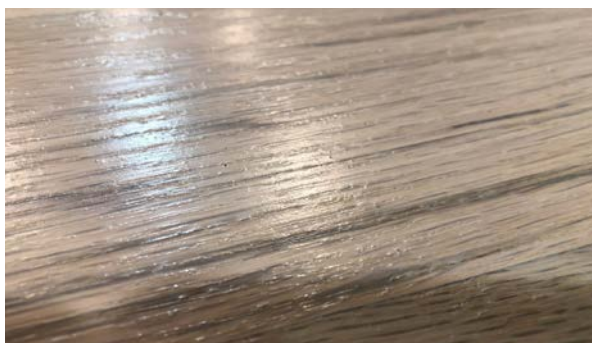
## Roughness/Grain-Raise

**DEFINITION:** The surface of the wood floor feels rough to the touch.

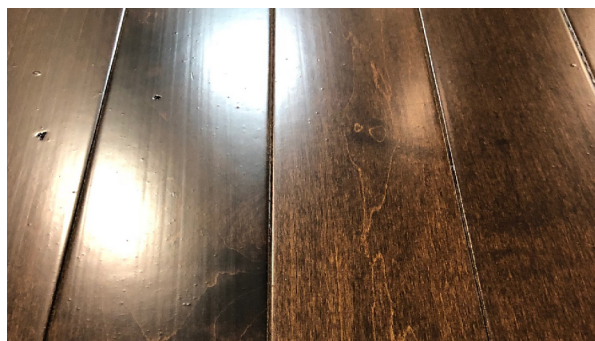
## Applicator/Finish Streaks

**DEFINITION:** Visible ridges, lines, or marks left on the wood floor, representing the application tool used from any stage of the finishing process.

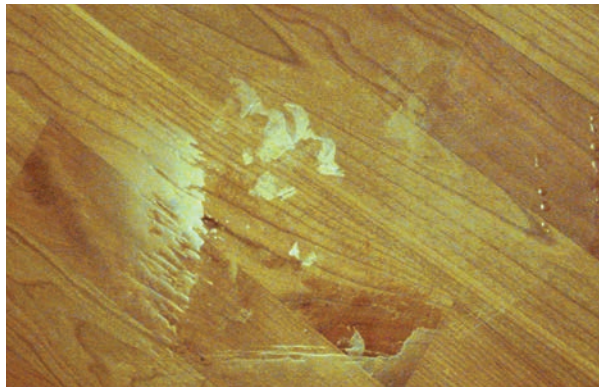
## Holidays/Skips

**DEFINITION:** An exposed area of uncoated wood or the undercoating, when the intention was to coat the entire area.

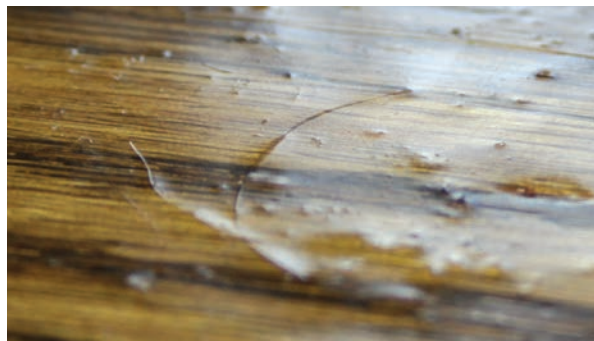
## Debris in Finish

**DEFINITION:** A raised bump in the film of finish often consisting of dust, hair, applicator fibers, foreign contaminants, solid finish particles, or other artifacts. Due to the nature of most coating environments, minimal amounts of debris within reason can be expected in any coat of finish.

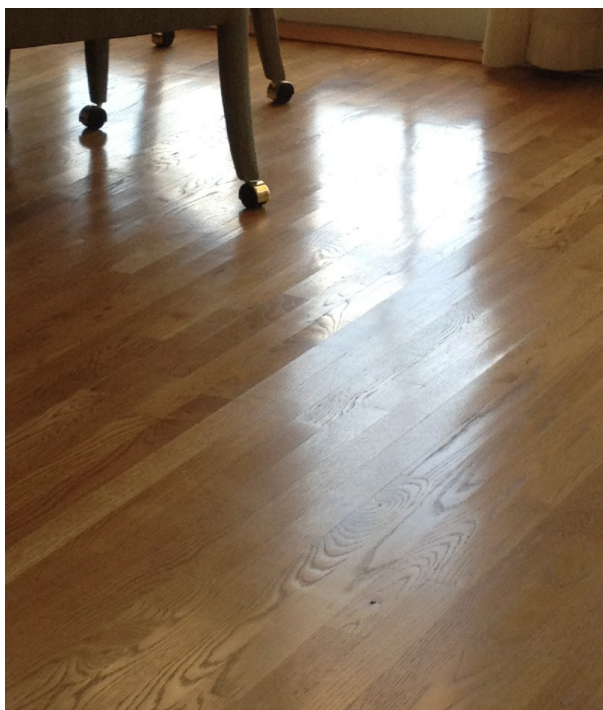
## Uneven Sheen/Gloss Levels

**DEFINITION:** The sheen or gloss level of the final coat of finish varies from one area of the floor to another. As film-forming finish products decrease in gloss, they increase in amounts of matting agents. Lower sheen products have the most matting agent, and thus, can more-easily manifest uneven sheen levels. Sheen/gloss levels should not be assessed until all final coats have been applied and are fully cured.

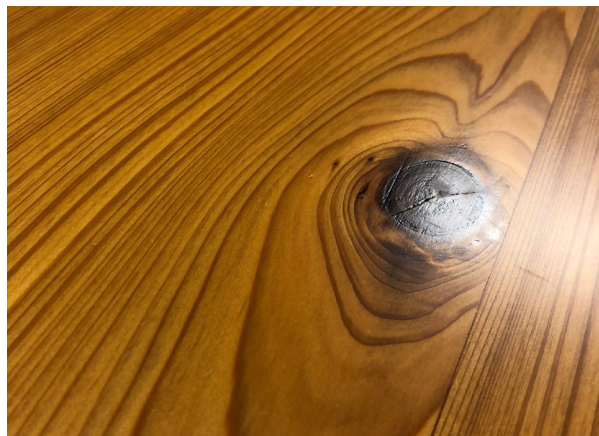
## Sticky Board Syndrome

**DEFINITION:** Wood floor finishes that do not dry, adhere, cure properly, or appear the same on specific areas of a board or individual boards.
