# PROBLEMS, CAUSES, AND CURES

Technical Publication No. C200 • Revised © 2018 | 3rd Edition

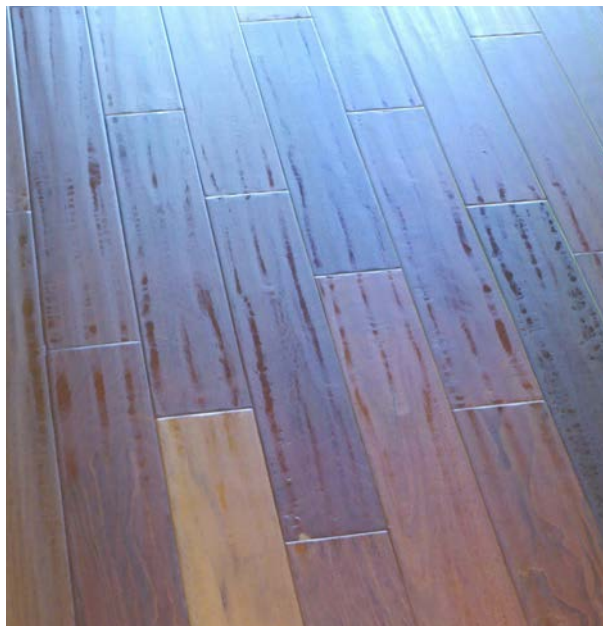
## Cloudy Finish

**DEFINITION:** An unintended white, milky, or cloudy appearance of an otherwise transparent, clear finish.

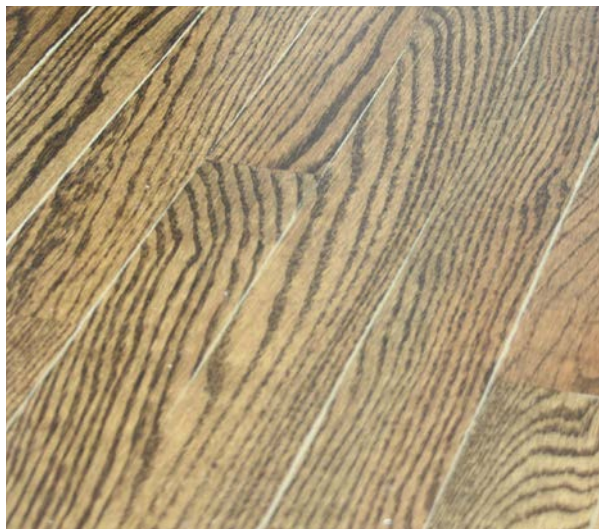
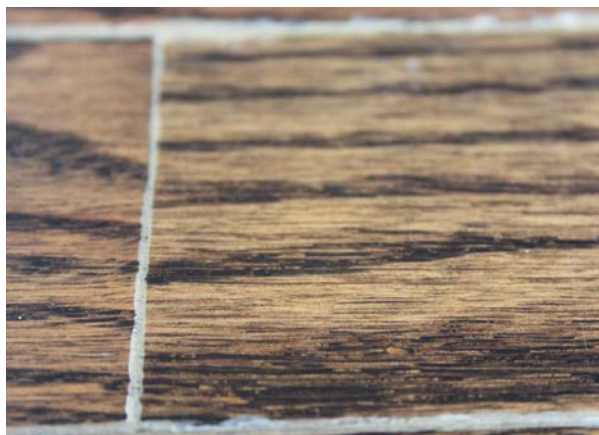
## White Lines

**DEFINITION:** White lines appear between board edges of site-applied film-finishes.

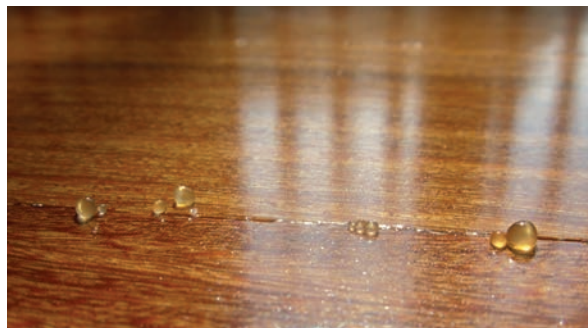
## Poly Beads

**DEFINITION:** Small round balls that appear as beads, or “BBs” of finish, that form along the joints of the individual boards. They can be soft and sticky when first formed, and will become hard if left undisturbed. When these wet beads are stepped on, they can become unsightly smears along board edges.

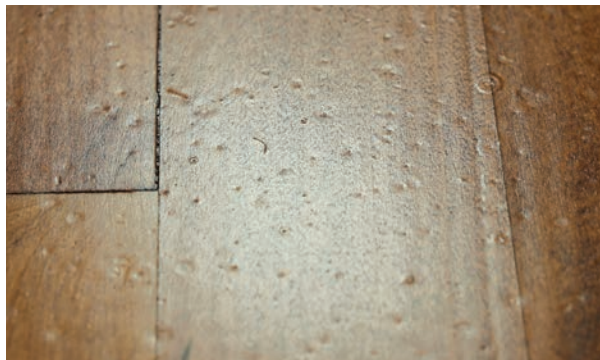
## Pin Holes

**DEFINITION:** A visible finish imperfection where the surface of the finish film recedes from a very small area or areas of the surface.

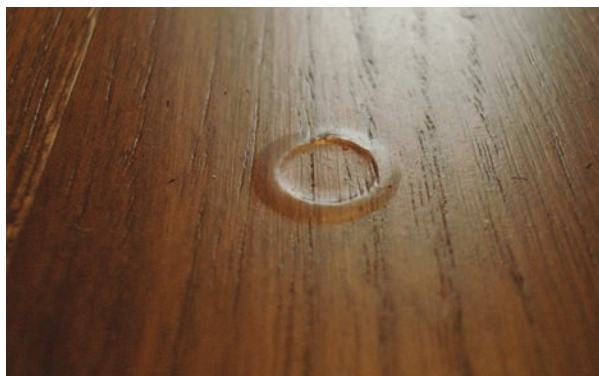
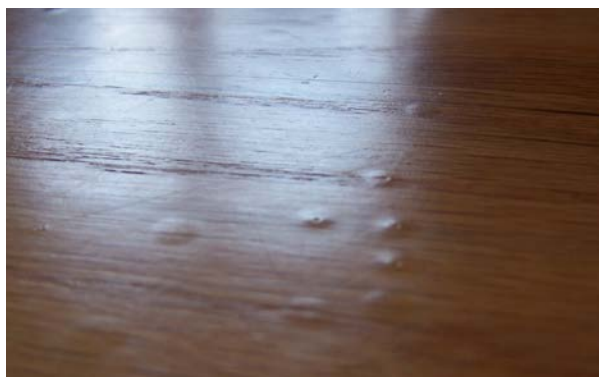
## Craters/Fisheyes

**DEFINITION:** A visible finish imperfection that manifests by the crawling of wet finish film into a single area or pattern resembling small dimples or bowl-shaped depressions, sometimes accompanied by a particle in the center.

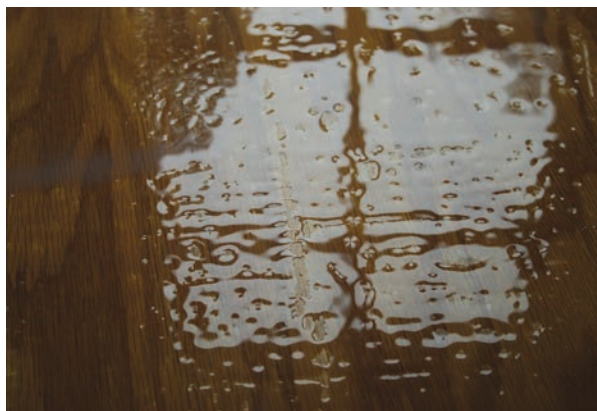
## Crawling

**DEFINITION:** A visible finish imperfection where the finish film is repelled from areas of the surface, leaving the appearance of thin or uncoated affected areas. May be very long and oval shaped, and may vary in size.

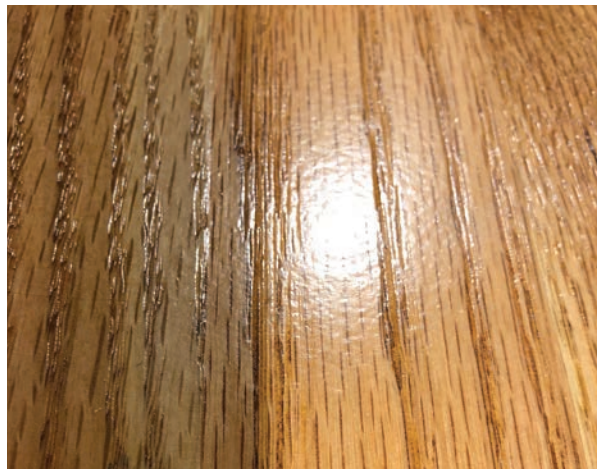
## Orange Peel

**DEFINITION:** A visible finish imperfection where the surface of the dry finish film exhibits a flaw that resembles the texture of an orange peel.

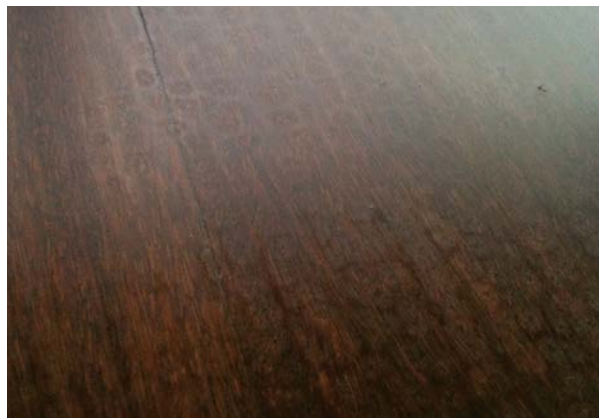
## Benard Cells

**DEFINITION:** A visible finish imperfection resembling a pattern in the smooth finish film that resembles a clustering of "cells." They typically appear as less-glossy, often round, curvy, or geometrical (hexagonal, pentagonal) in shape, and may range in size from very small, up to 1". Benard cells are more common with lower sheen or pigmented finishes.

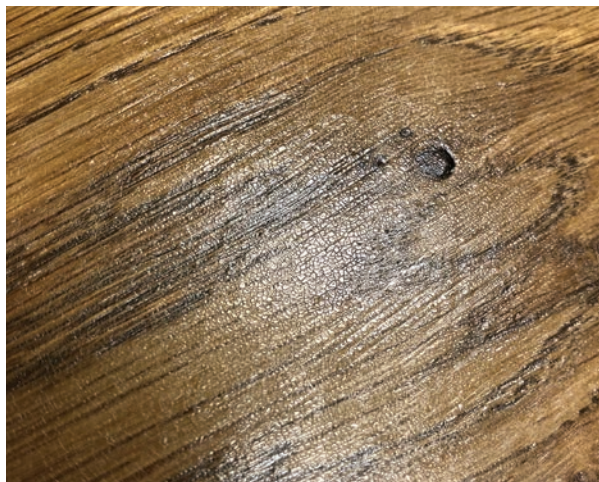
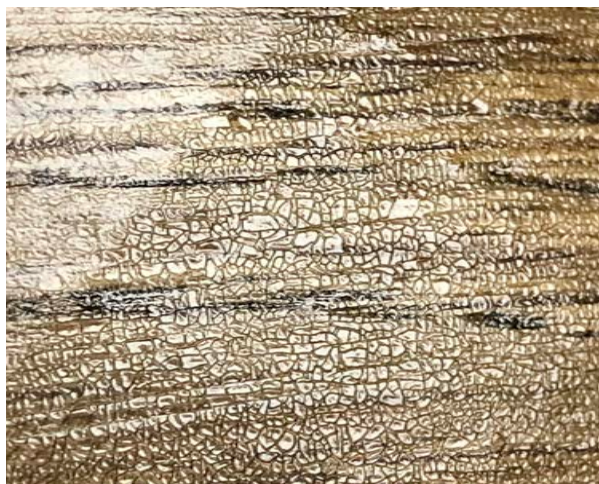
## Crazing/Alligatoring

**DEFINITION:** A visible finish imperfection that appears as a network of very small, fine cracks or fissures in the surface of the finish film, which sometimes resembles the skin of an alligator or crocodile.

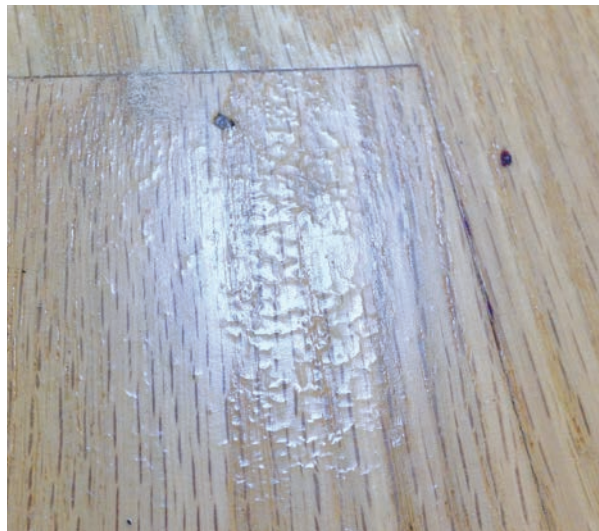
## Wrinkling

**DEFINITION:** A visible film-finish imperfection that appears as the skin of a dried prune. Wrinkling may happen with all types of film-finish, but is most common with oil-based urethanes.

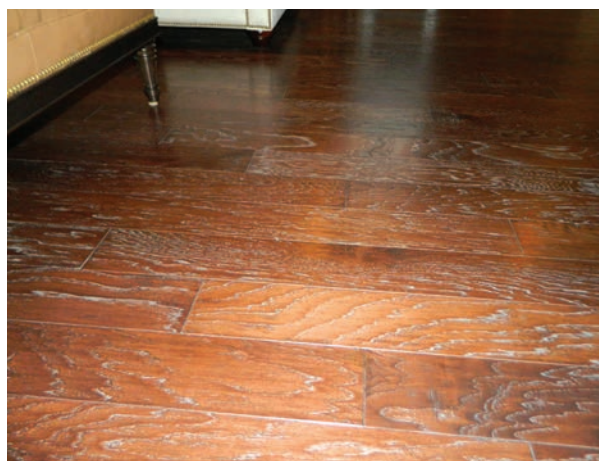
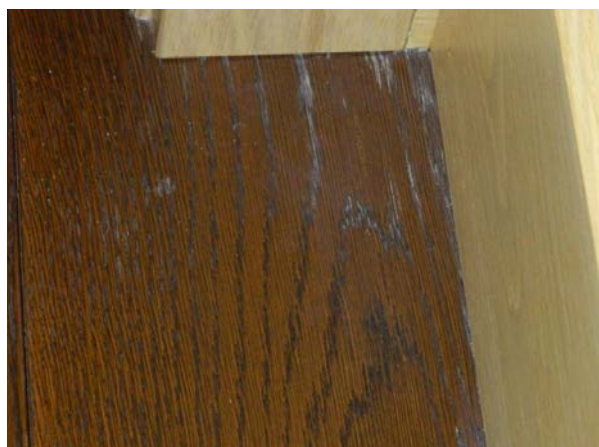
## Open-Grain Contamination

**DEFINITION:** An accumulation of contaminants in open voids or characters, such as in textured wood, the soft grain/springwood, open knots, splits/checks, etc., on the surface of the installed floor.

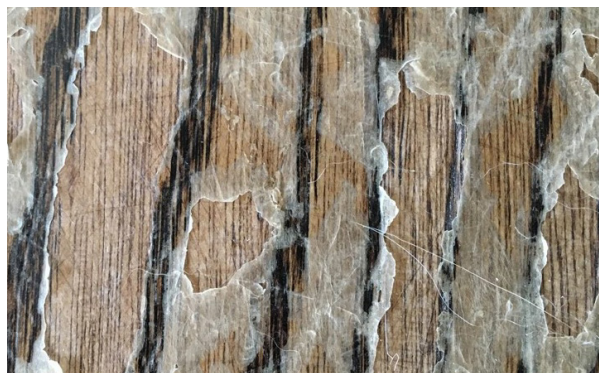
## Finish Adhesion Failure

**Peeling Finish** - The condition that occurs when a dried film of finish separates from the underneath surface in the form of large pieces or sheets.

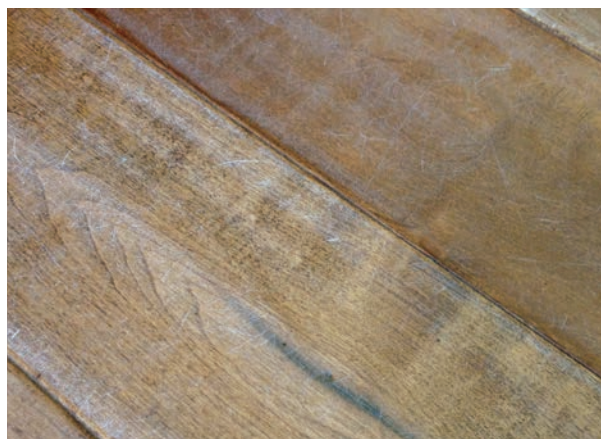
## Finish Wear Discrepancies

**DEFINITION:** The performance of the surface coat of finish not meeting expectations.

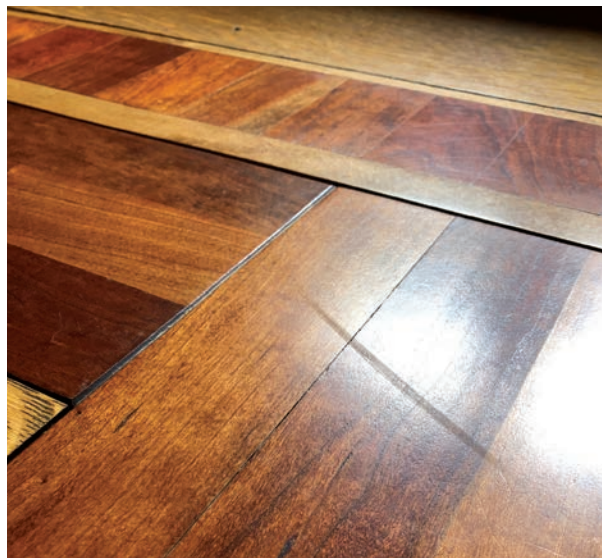
## Scuffing

**DEFINITION:** Marks or abrasions left on a wood floor surface or finish.

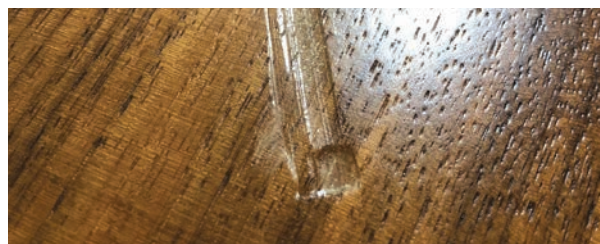
- Finish systems may be marred or scuffed, either from chemicals or from heat generated by sliding objects across them. These may look like scratches, but are not.
- Surface scratches are typically only in the finish coats. A fingernail can't feel the ridge.
- Deep scratches are typically through the finish coats and have torn the wood fibers.
- Cross-grain scratches are deep scratches, and are oriented perpendicular to the direction of the flooring, often crossing multiple board widths and have a higher probability of exhibiting wood fiber tear. Deep scratches, usually termed "gouges," are typically through the finish coats and have torn the wood fibers.
- As scratch damage increases in severity, so does the likelihood that the damage will also include denting.
- **Indentations** - notches, grooves or depressions on the surface of the flooring.

- Indentations are caused by applied vertical and/or horizontal forces on the flooring surface.
- When only vertical forces have been applied (dropping an object) these depressions are typically isolated to the shape of the portion of the dropped object that contacted the floor.
- Indentations may not always be accompanied with finish tear/fracture.

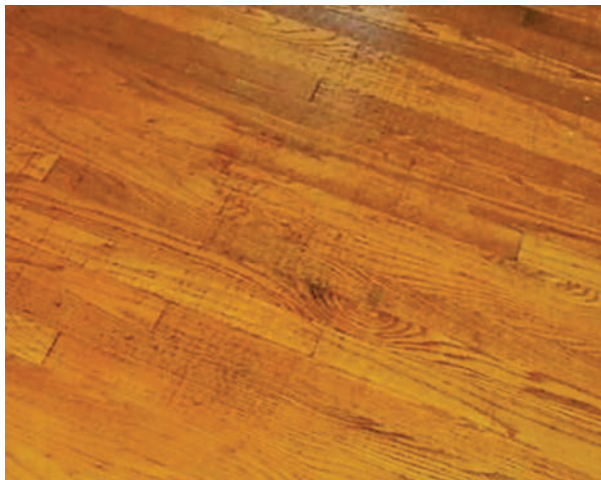
## Surface Impressions

**DEFINITION:** A shape or pattern imprinted on the face of the board, which resembles an item or object that had been in direct contact with it.

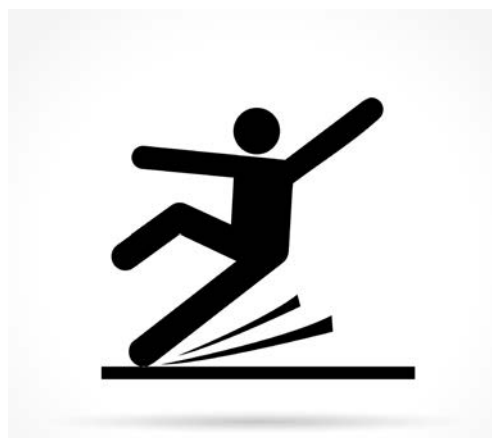
## Slippery Floors

**DEFINITION:** The perception that the floor feels slippery. All wood floor finishes could be considered slippery with normal use. Most wood floor finishes are not usually considered to be slip-resistant, and some wood floor finishes feel slipperier than others.
